## Solution to Safely Tip Powered Wheelchairs for Air Travel

### Abstract

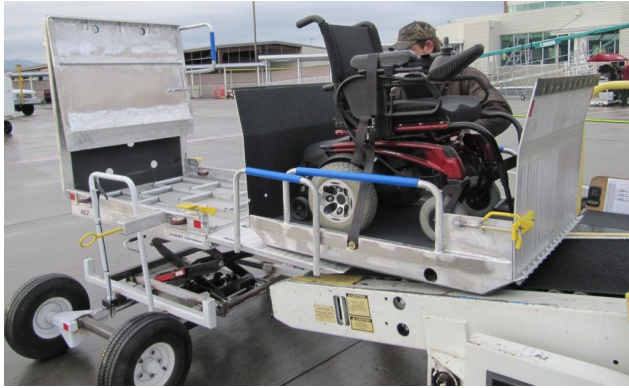
**Example of a KCI powered wheelchair trailer lift barge being transferred onto belt loader**

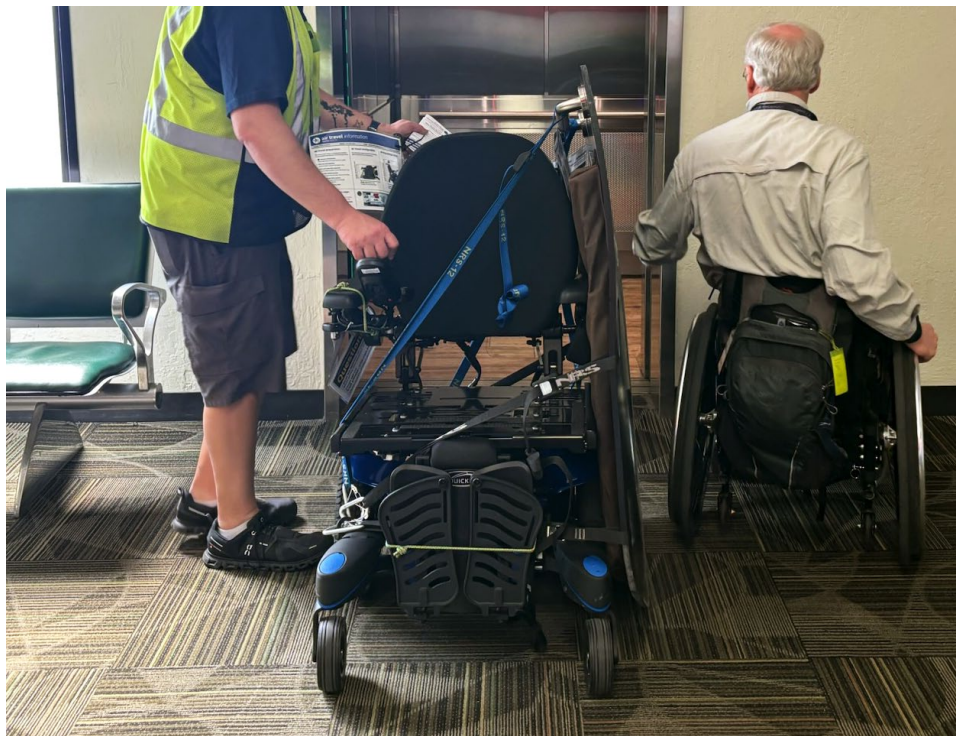
**Figure 1** Padded Tipping Plate attached to a powered wheelchair

Tipping any powered vehicle requires holding onto the frame structure of the vehicle for securement and protection. Automobiles are regularly transported when secured by holding onto the frame structure. A powered wheelchair is designed with four anchor points that are connected to the strong frame structure. These anchor points are designed for securement in motor vehicles and are crash tested to 20-g test loads while the powered wheelchair remains occupied with a weighted test mannequin. The flexible Padded Tipping Plate is strapped and secured to the two anchor points on the side of the powered wheelchair opposite the joystick. Prior to final tightening of the straps and tipping, the wheelchair can continue to be driven wherever necessary.

Once the straps are fully tightened and secured, one person can safely tip the heavy powered wheelchair. High-tech padding provides cushioning between the Padded Tipping Plate and the powered wheelchair, distributing the weight of the wheelchair and protecting the drive wheel, frame, arm support, and back support while tipped, as demonstrated by the extensive RESNA drop testing.

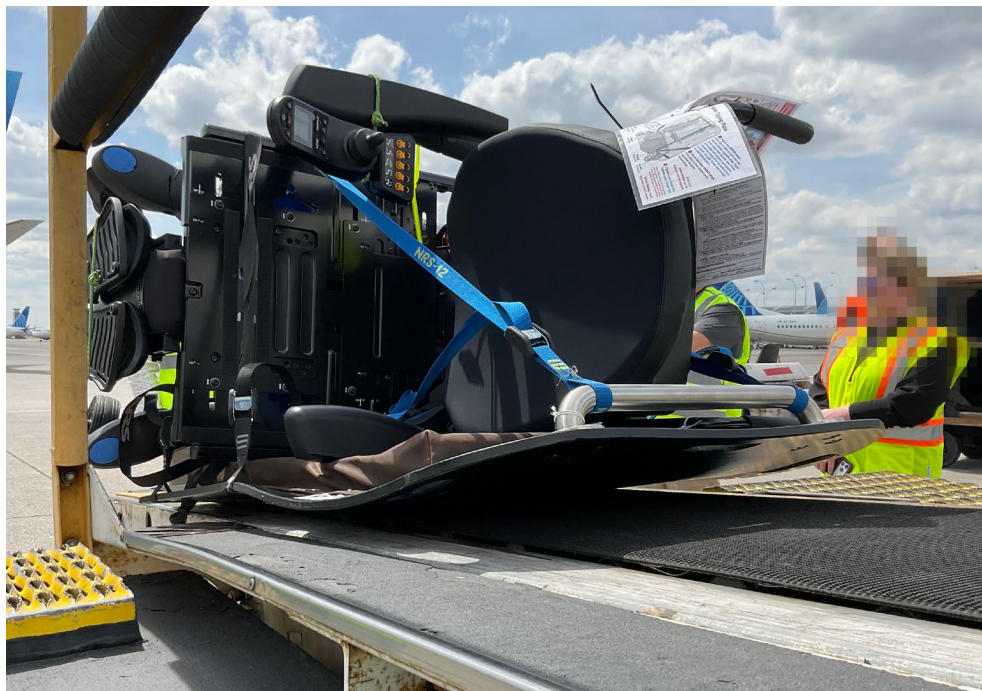
**The front and sides of the PTP flex upwards**

The Padded Tipping Plate eliminates damage that could result from lifting or moving the powered wheelchair using the seating system or other weaker components by enabling efficient movement of the tipped wheelchair. The sides and front of the Padded Tipping Plate flex upwards off the ground, creating a movable tray or “sled” that facilitates safe and easy sliding and pivoting over uneven surfaces. As a result, the tipped side of the powered wheelchair is prevented from contacting any surfaces during movement, while the full seating system remains safe within the perimeter of the Padded Tipping Plate.

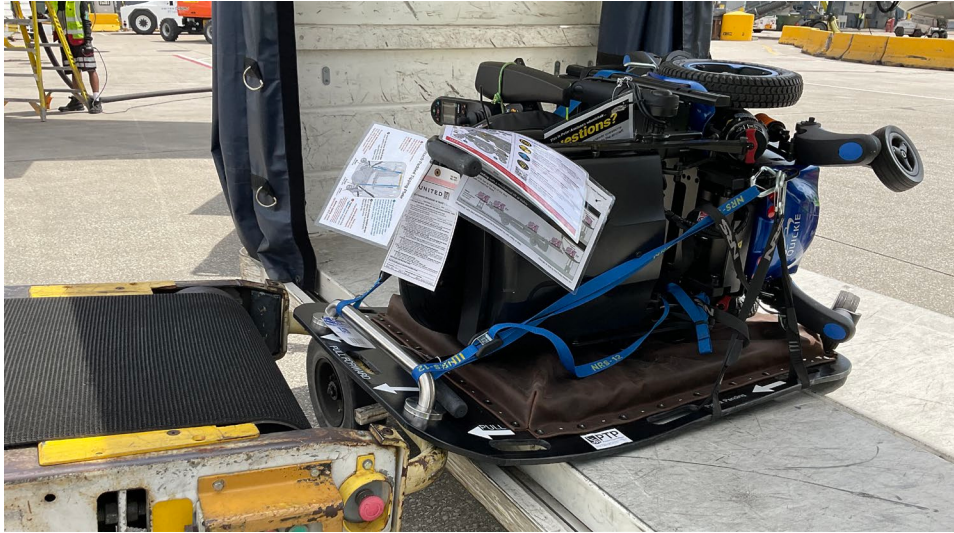
**Tipped PWC-PTP package ready to be transferred from baggage trolley to belt loader**

Rather than tipping the powered wheelchair on the belt loader, the Padded Tipping Plate allows tipping to occur prior to loading onto the belt loader. Once tipped, the powered wheelchair remains safe and ready to be loaded. The tipped powered wheelchair attached to the PTP can be manually or hydraulically lifted to a baggage trolley, from which the package can be easily moved onto the belt loader.

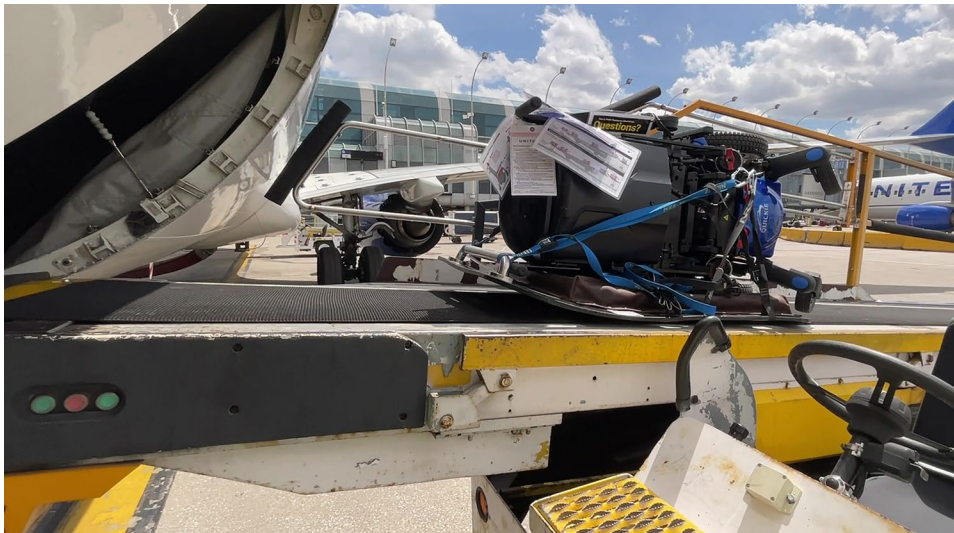
**Tipped PWC-PTP package ascending belt loader**

Once on the belt loader, the package can ascend with little to no guidance up to the cargo door and into the cargo hold. The low center of mass and evenly distributed surface of the tipped powered wheelchair-PTP package resists rolling or tipping, keeping the powered wheelchair safe and stable on the belt loader.

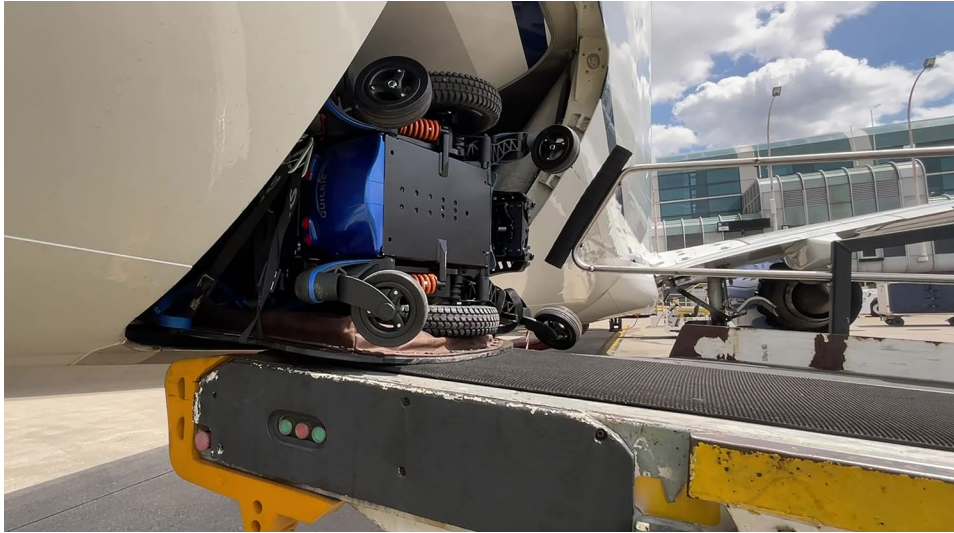
**Belt loader pushes PWC-PTP package into a Boeing 737 cargo hold**

The package then easily transitions across the gap between the belt loader and the cargo door, sliding safely into the cargo hold. The moving belt helps to move the device, while ground crew members can push on the strong base frame or wheels of the wheelchair and pull on the grab bar at the front of the tipped package.

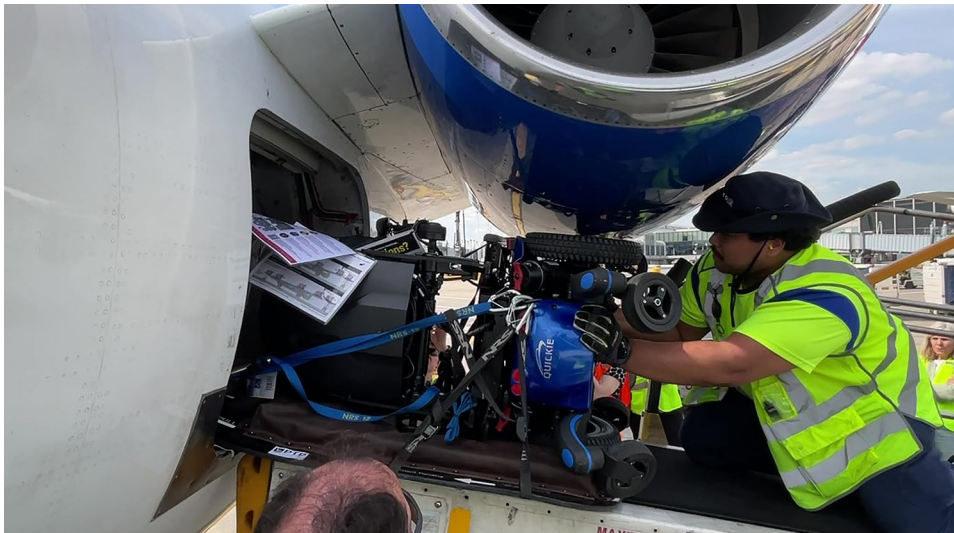
**Loading the PTP-PWC package into a CRJ-200**

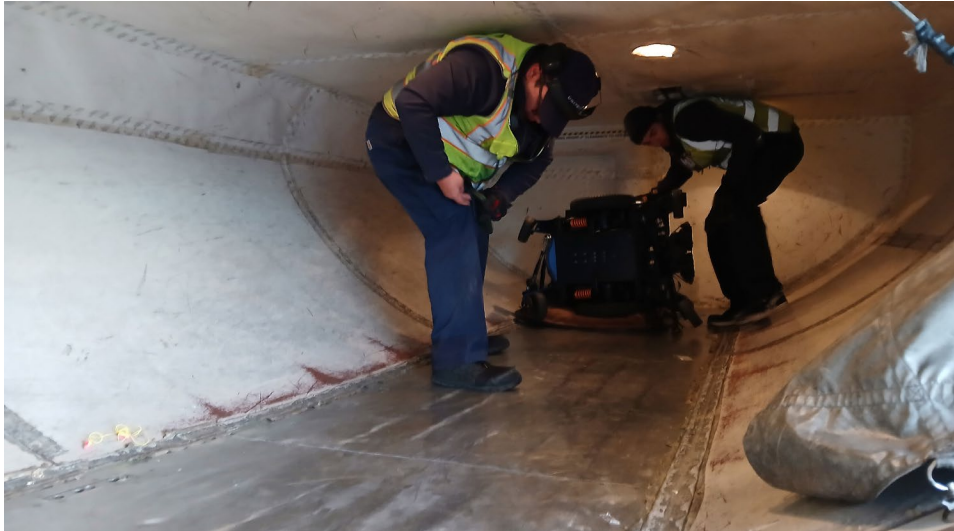
**Ramp agents position the PWC-PTP package for air travel in a Boeing 737 cargo hold**

Once inside the aircraft, the tipped powered wheelchair-PTP package is rotated for positioning and securement, using the PTP hand holds or the securement straps. As a result, ground crew members no longer have to handle parts of a powered wheelchair that are not designed to move the weight of the device.

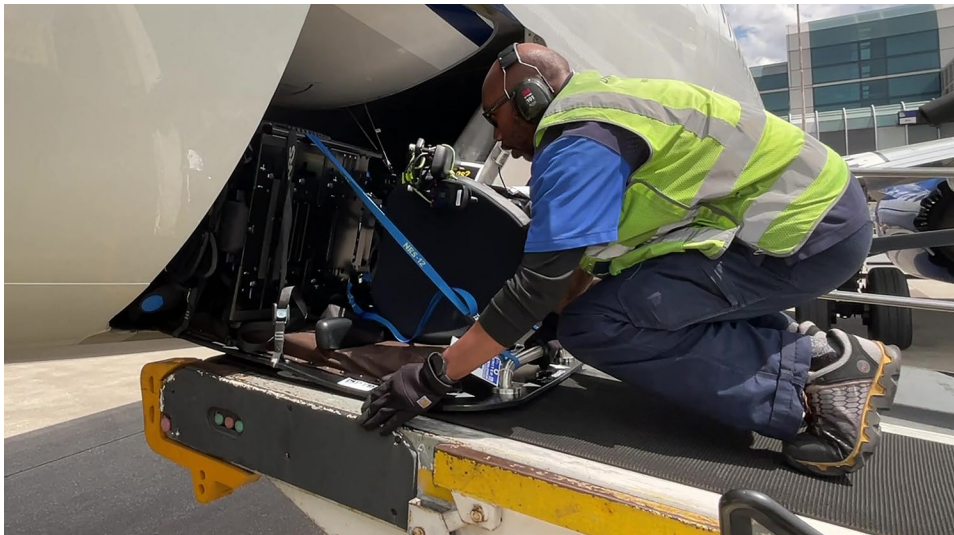
**Unloading the PWC-PTP package from a Boeing 737**

The unloading process is similar to the loading process as the powered wheelchair-PTP package transitions onto the belt loader, where it descends and is then transferred to a baggage trolley or a hydraulic lift. The powered wheelchair-PTP package can be manually or hydraulically lowered to the ground into the upright position for disassembly and preparation of the wheelchair for use.

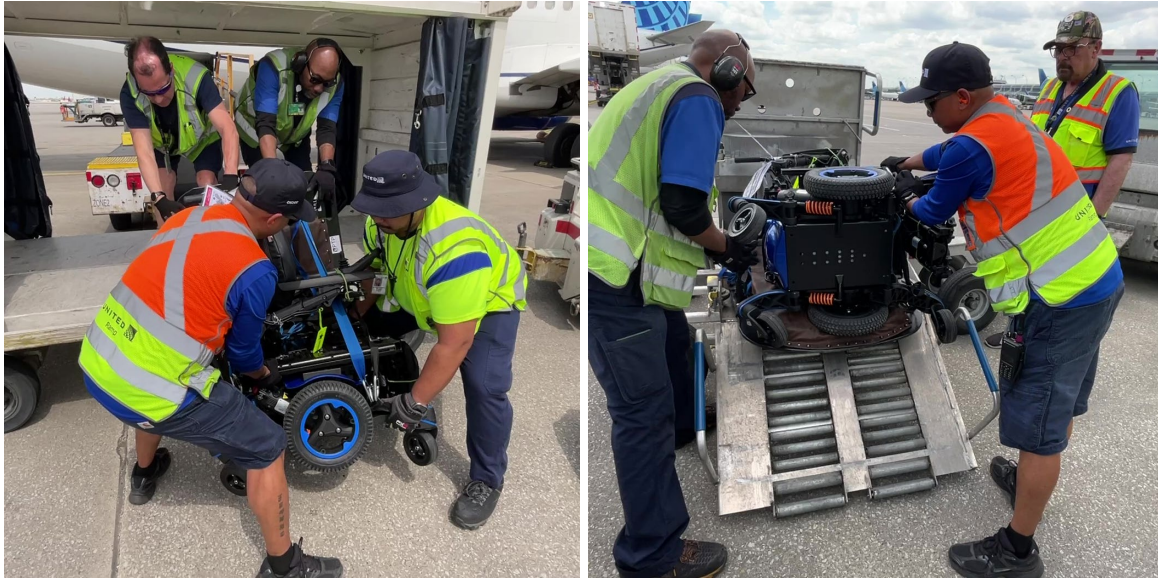
**Manually lowering the PWC-PTP package to the ground from a baggage trolley and a KCI wheelchair trailer lift**

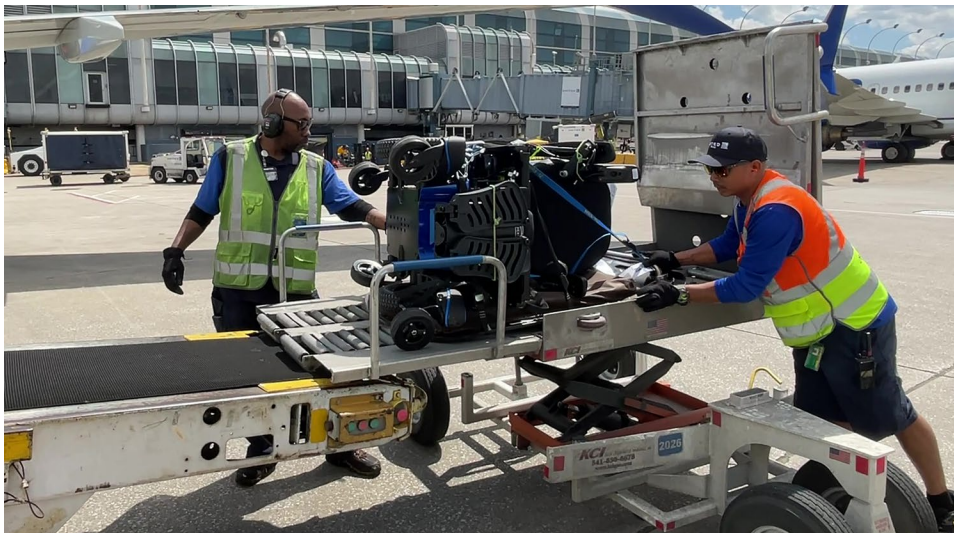
**Using a KCI wheelchair trailer lift to transfer the PWC-PTP package**

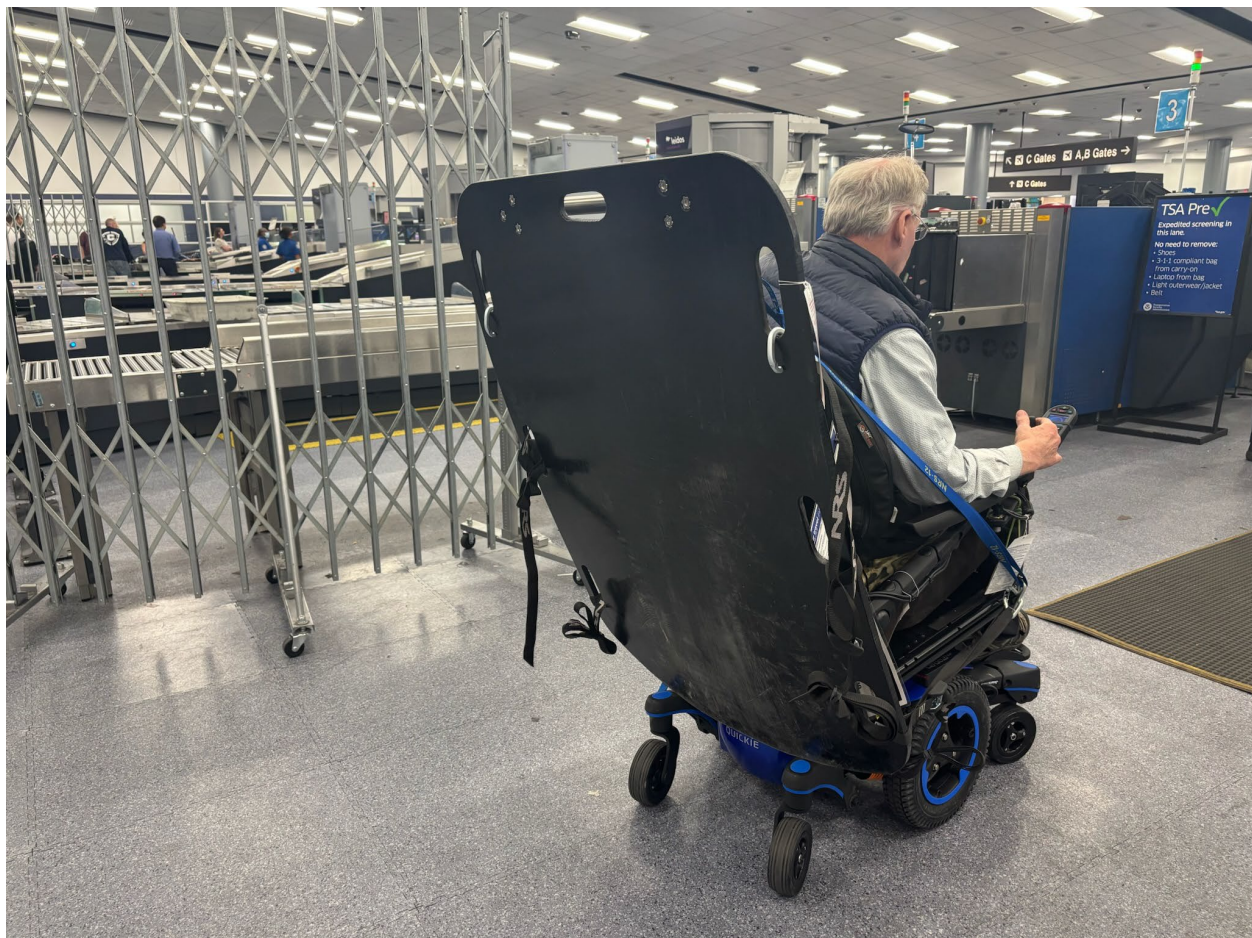
**The PTP rests upright on the rear casters of a powered wheelchair**

The Padded Tipping Plate may be mounted and strapped to the backside of a powered wheelchair to carry to and from the airport. The plate rests on the rear casters and the straps attach to the front of the seat frame. The user of the powered wheelchair may sit in and drive the wheelchair while the PTP is attached to the back.

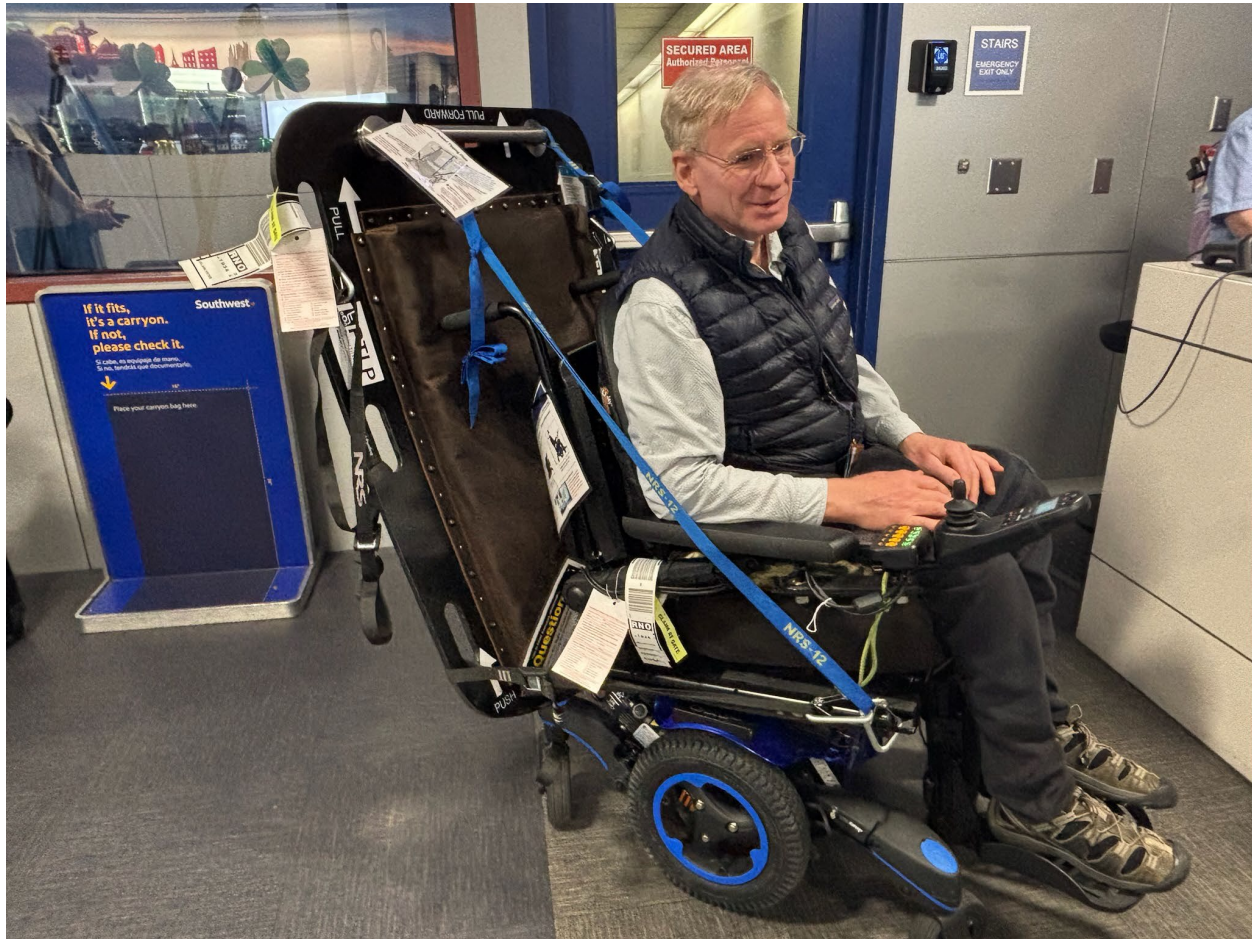
Top and bottom straps hold the PTP against the rear side of the powered wheelchair
