# Bartley Ranch Regional Park and Anderson Park

## A Trail Access Information

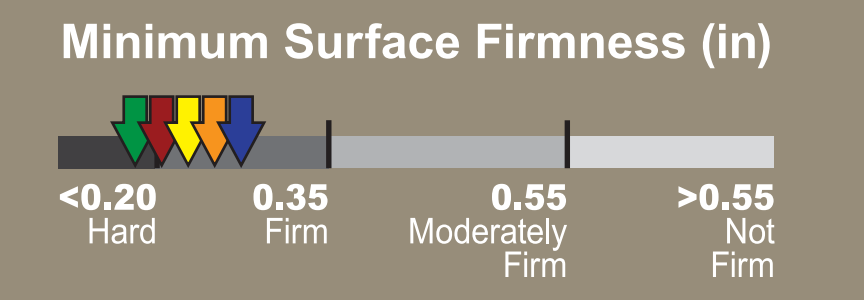
Trail Name	Length	Typical Grade	Maximum Grade <small>Standard Ramp is 8.3%</small>	Typical Cross Slope	Maximum Cross Slope	Typical Trail Width	Minimum Clearance Width	Surface Type	Surface Firmness		Surface Stability	
									Typical	Worst	Typical	Worst
Ranch Loop Trail	1.5 mi	4.5%	371 ft is 16% – 25%	2.8%	18 ft is 16% – 20%	90 in	40 in	Aggregate/Gravel	0.19	0.22	0.36	0.60
Quail Run Trail	0.4 mi	7.3%	186 ft is 20% – 40%	3.5%	46 ft is 18% – 30%	60 in	25 in	Aggregate/Gravel	0.19	0.22	0.39	0.50
Flume Trail	0.2 mi	4.6%	37 ft is 14% – 19%	3.9%	47 ft is 12% – 14%	48 in	20 in	Soil	0.23	0.25	0.38	0.49
Anderson Trail (Round Trip)	1.7 mi	2.5%	196 ft is 14% – 21%	2.4%	311 ft is 7% – 11%	76 in	48 in	Aggregate/Gravel	0.19	0.22	0.39	0.52
Park Loop	0.2 mi	1.6%	64 ft is 4% – 5%	1.8%	230 ft is 3% – 4%	84 in	84 in	Aggregate/Gravel	0.18	0.19	0.37	0.43
